Problems of Chronology in Gandhāran Art

**Proceedings of the First International
Workshop of the Gandhāra Connections Project,
University of Oxford, 23rd-24th March, 2017**

Architectural evidence for the Gandhāran tradition after the third century

Kurt Behrendt

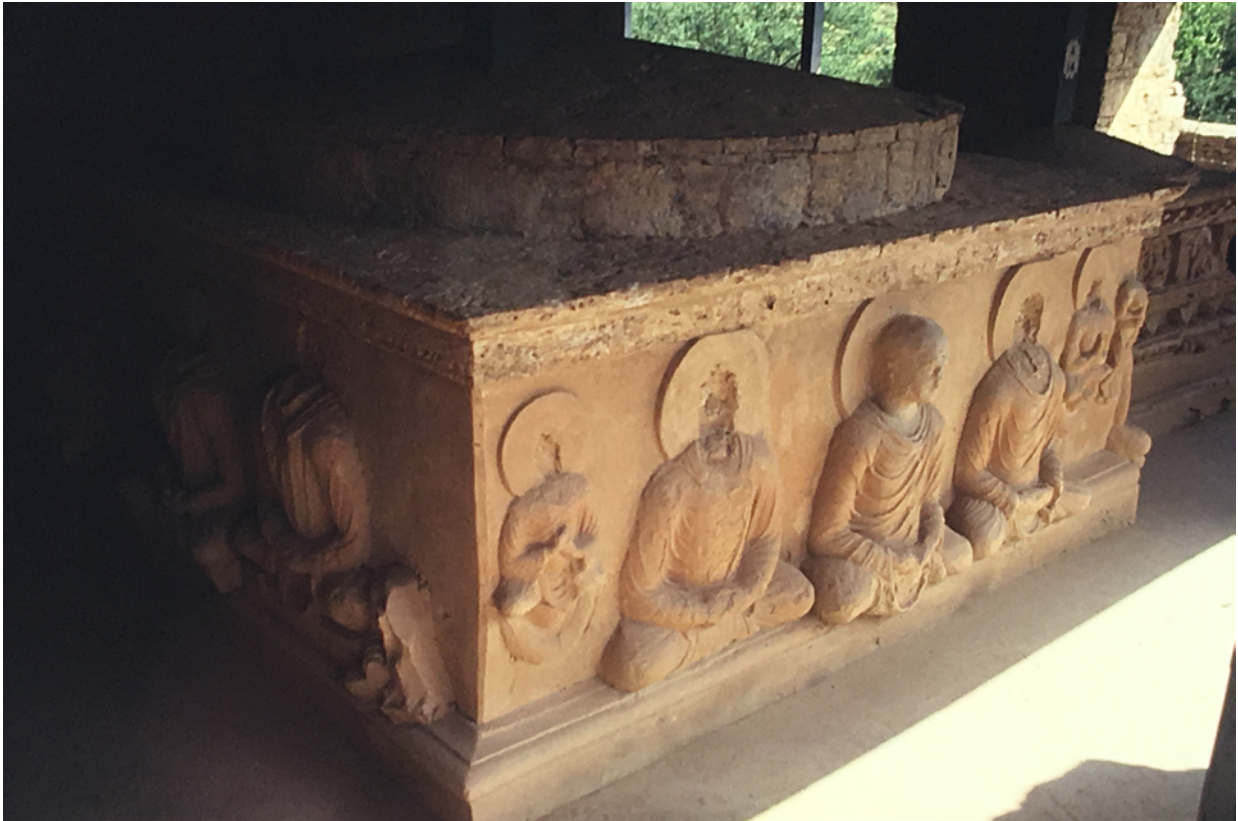
Figure 5. Jauliān small stūpa A15, south face; diaper masonry stūpa with later stucco Buddha images.
(Photo: Kurt Behrendt, 1992).

The surviving sculptural evidence at Jauliāñ is consistent with this late dating as a huge amount of stucco imagery survives at this site – some of it at a very large scale. *In situ* stucco imagery survives on the main *stūpa* and embellishing many of the small *stūpas* (Figure 5) and one thousand small heads and many other fragments were found in the sacred area (Marshall 1951: 384). Stucco assemblages of figures with particularly late iconography occur in seven small shrines that were added to the monastery (Behrendt 2004: 171-174). In contrast, no phase II schist narrative reliefs were found. Of the five schist sculptures recovered from Jauliāñ three are large devotional icons and two are small fragments (Marshall 1951: 384).

At Jauliān the compact placement of small stūpas around the main stūpa follows a consistent pattern that can be observed at many sites across Gandhāra, good examples being the lower stūpa court at Takht-i-Bāhī (Figure 11), Mekhasanda (Figure 7) and the early stūpa court around the main stūpa at Ranigat (Figure 8). A clear pattern emerges suggesting that the most desirable location for a patron to build a small stūpa is adjacent to the stairway of the main stūpa. However, at Jauliān the small stūpas in this location (A2 and A20) are fabricated in kanjur masonry sitting on bases done in semi-ashlar masonry, their surfaces being embellished in stucco imagery. Their location suggests they are likely replacements for earlier structures built in conjunction with the main stūpa. The only diaper masonry stūpa to survive in this court (A15) (Marshall 1921: 4) sits off to the side in a rather undesirable location indicating that it was added at a point when all the space bracketing the front of the stūpa had been filled with other stūpas; it too is embellished with fairly large stucco Buddha images, suggesting refurbishment (Figure 5).

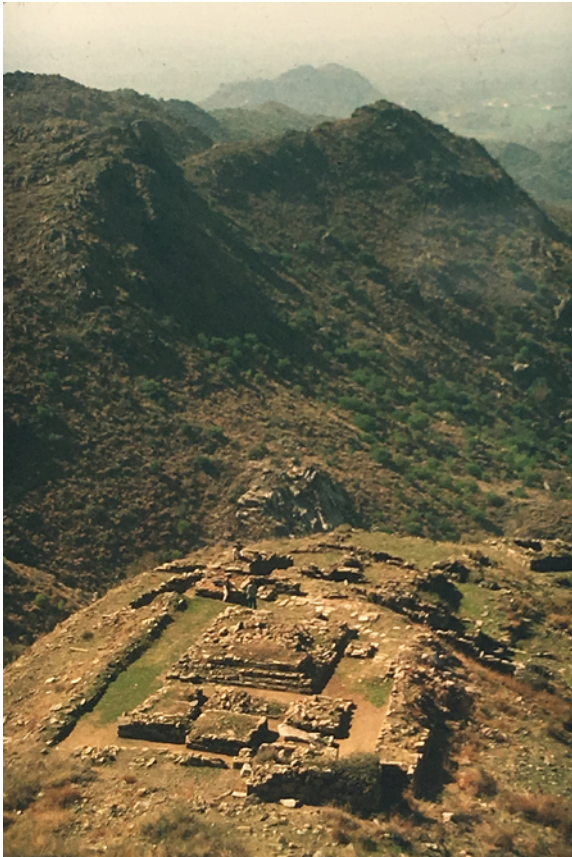
Figure 6. General view of Mekhasanda, Peshawar Basin (Photo: Kurt Behrendt, 1993).

A key Peshawar Basin site that can be productively compared to the sacred precincts in Taxila is the small, relatively simple complex of Mekhasanda in the hills above the town of Shābāz Garhī (Figure 6). The site appears to have a phase II foundation and an occupation that continued into the late period of Gandhāran activity (Table 1). While only nine coins were recovered, they do support this dating. Relating to phase II are coins that include one of Kaniṣka I (AD 127-150) and one of Huviṣka (AD 151-189), with phase III corresponding to one of Vāsudeva (AD 190-226), five Vāsudeva imitations (AD 268-308 or later), and one Kushan-Sasanian coin (Mizuno 1969: 94-95). Fortunately, a considerable amount of sculpture was found that also helps in establishing the relative chronology. Phase II occupation is evidenced by three small *stūpa* domes, five narrative panels, fifteen fragments of narrative panels, four sections of schist false gables and 210 related schist architectural fragments (atlantes, lions, garland-bearers, rows of small seated Buddhas in niches and various decorative motifs) (Mizuno 1969: 90, pls. 39-49). Four of the narrative fragments were found in the debris of a looter's hole dug into the core of the main *stūpa*, damaged sculptures that appear to have been deposited at the time of the main *stūpa*'s encasement. Although the form of the original phase II main *stūpa* is obscure, the plinth of the core structure extends under the bases of small *stūpas* 2 and 4, suggesting that they were likely built in phase II soon after the original main *stūpa* was established (Mizuno 1969: 83). Small *stūpas* 3 and 5 may also have an early date though this is less certain. Here the evidence of refurbishment possibly following an earthquake is clear as no early *stūpas* are extant at the site, but considerable quantities of early broken sculpture are present. It seems that at some point all of the early monuments were refurbished.
